# CASE STUDY

## Lihue Airport, Kauai Hawaii

**Project:** Lihue Airport Terminal, Metal Roof – Kauai, Hawaii, 2009

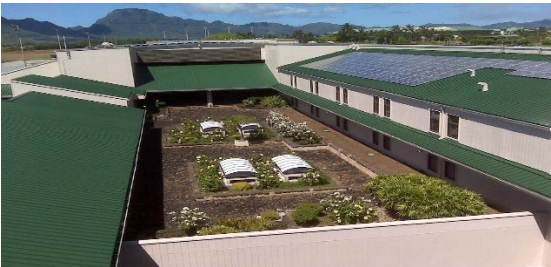
To the right, is a snapshot of Lihue Airport terminal in Kauai, Hawaii, showing the coated metal roof approximately 17 years after application.

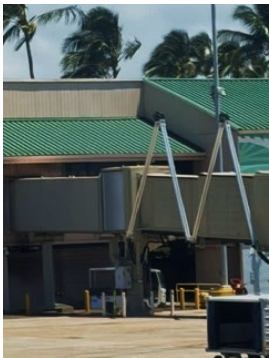
- Updated photographs taken in 2026 show the terminal's metal roof continues to maintain a well-preserved appearance.
- Based on visual observation, the coating exhibits minimal apparent fading after approximately 17 years of continuous outdoor exposure.
- The finish appears to have maintained good overall color consistency despite prolonged exposure to Hawaii's tropical sun, rain, humidity, and coastal conditions.

Closer view of the coated metal roof in 2026, showing the continued appearance and color consistency of the finish.
